All But Forgotten

99 railcars, a caboose and three engines of the Chicago, Milwaukee, St. Paul and Pacific Railroad Company Train 263 departed the Harlowton, Montana rail yard on May 23, 1966 at 8:20 p.m., but never completed the trip. All four members of that train crew survived the wreck in Sixteen Mile Canyon, but today only one remains to commemorate the 40th anniversary of the derailment.

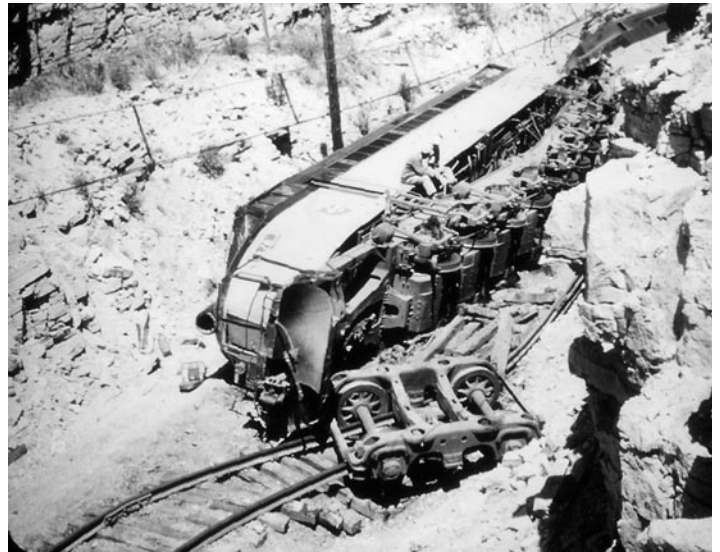
The lead engine, E78, on its side in the cut almost half-way through the curve.

Engineer Del Hart, Conductor E. L. Eck, Rear Brakeman Jim Skornogoski and Head Breakman Jim Satake were all experienced railroaders at the time of the derailment. Excessive speed in the 10 degree curve with a downhill grade caused the three engines of the train to lay over on the outside of the curve, but Engineer Del Hart insisted that he had applied braking without result and had hopes that the train would hold to the track up until the last thirty seconds, when he threw the train into emergency braking. Little Joe No. E-78 left the track only 41 feet into the curve.

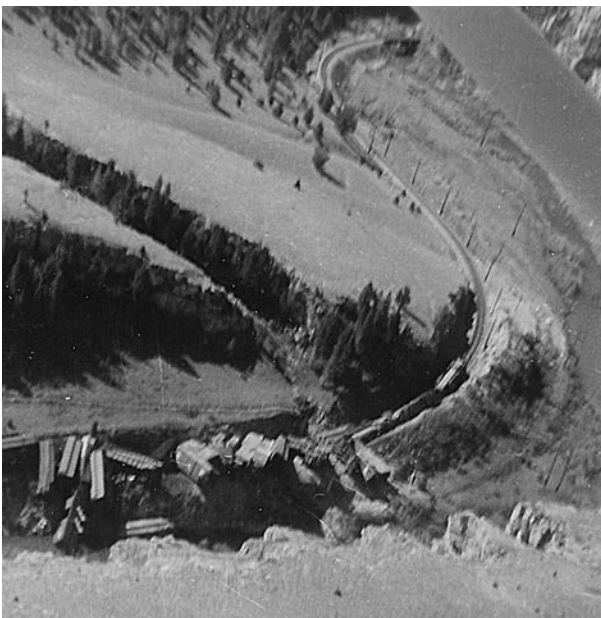
Left - The engines and cars derailed in the first group.

The train, originally about a mile long, was now only 6/10th of a mile long. The two electric's E-78 and E-73 and the diesel booster No. 263 were laid out on the north side of the curve. Directly behind them, 24 cars were compacted into a 300 foot space. The next 22 cars were upright and on the track, followed by another 26 cars crunched into a 353 foot area. The last 27 cars and the caboose were upright and on the rails. It was a mess.

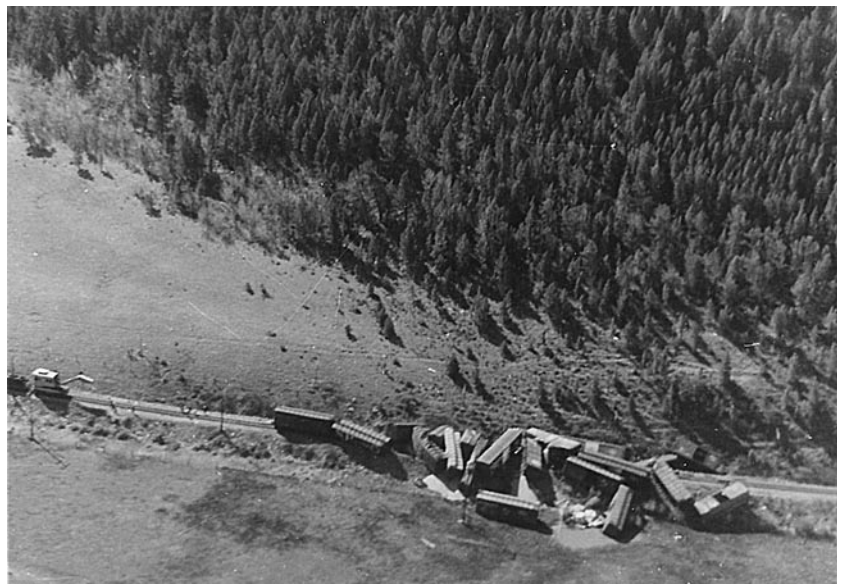
Below - The cars derailed in the second portion of the train.

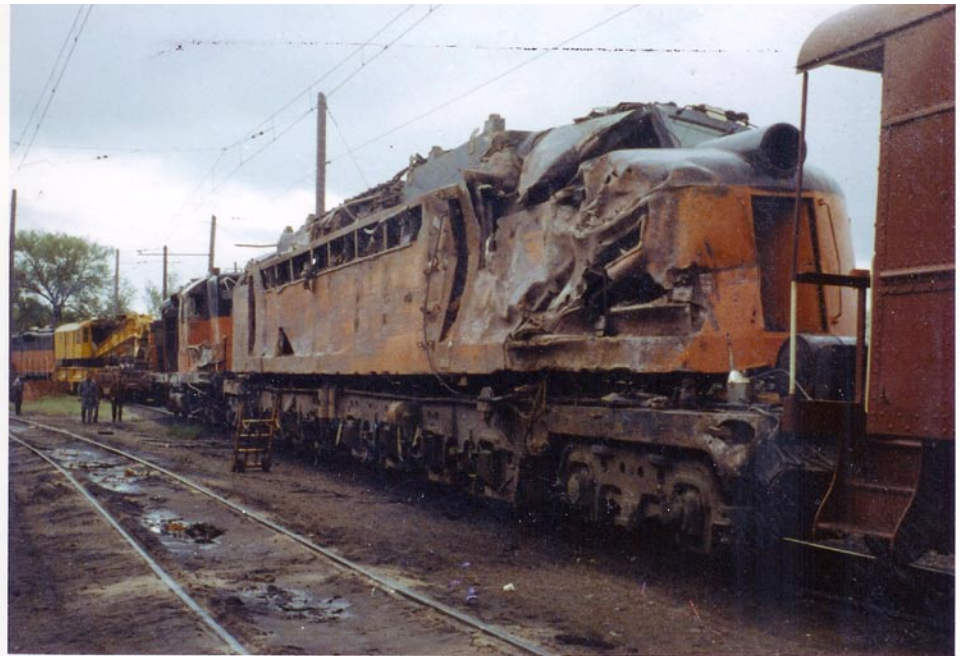
Top Right - E-78 and E-73 after they were uprighted and brought into the Harlowton yard.

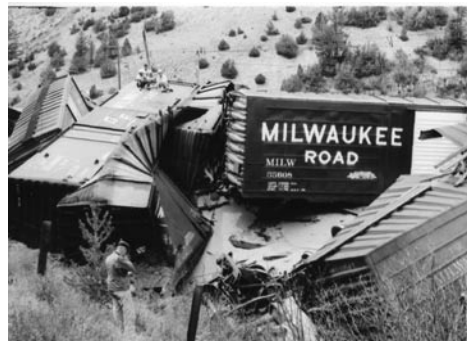
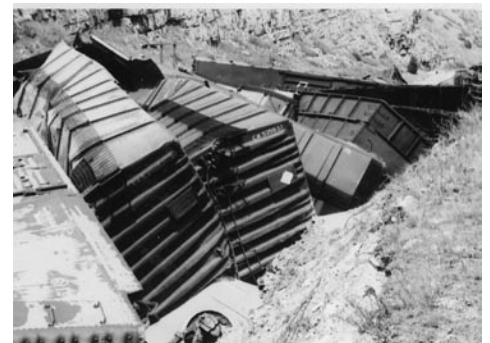
Middle Right - two views of the railcars crammed into the cut behind the engines.
